RE: Eskbank Railway Station

Priorities in the Conservation and Restoration of Eskbank Railway Station

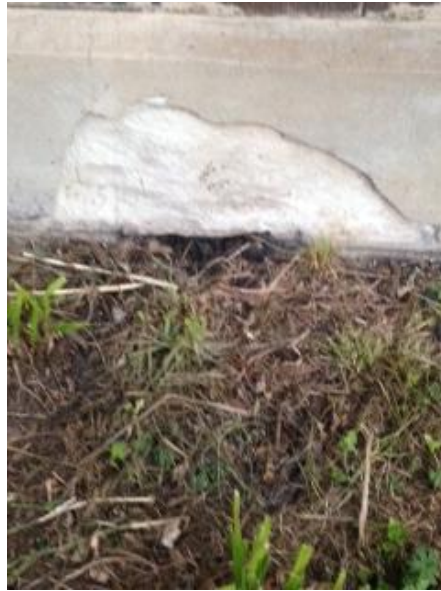
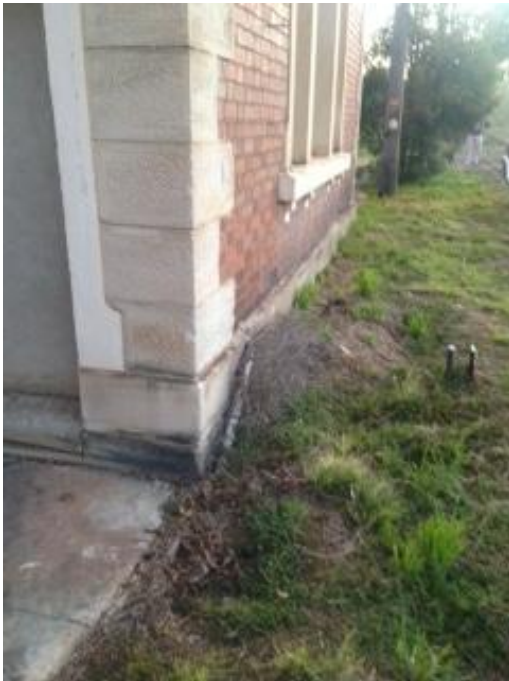
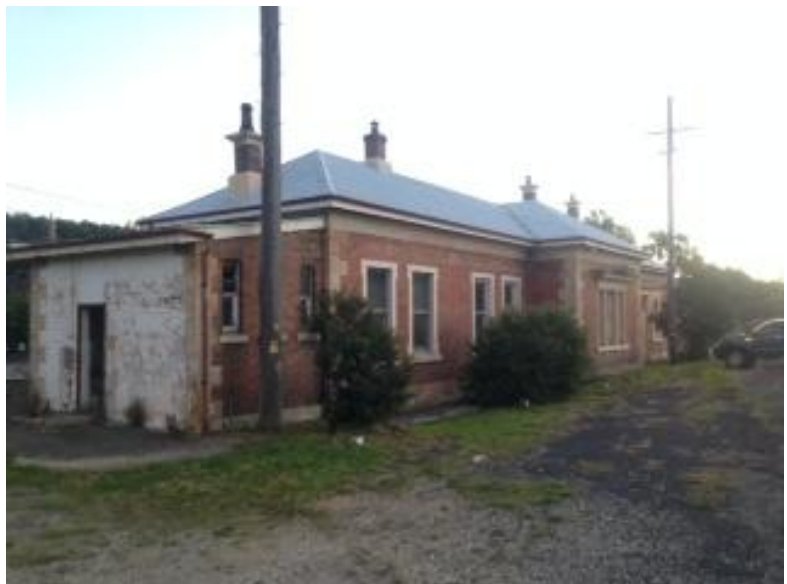
Much of the deterioration to Eskbank Station is occurring due to excessive ground moisture (rising damp).

Timber floors are rotting and suffering from white ant damage due to damp ground conditions.

Sub floor vent 'buried' under increased ground levels

I would advise to regrade external ground levels to ensure rain water runoff falls away from building.

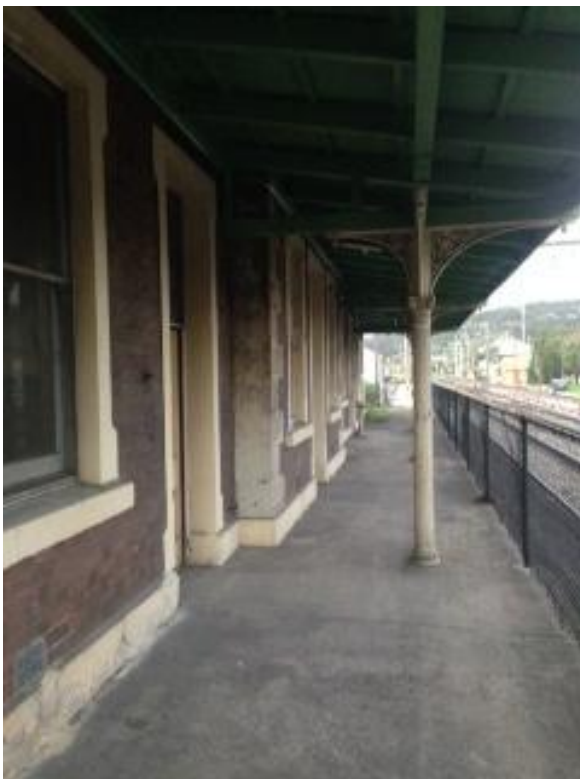
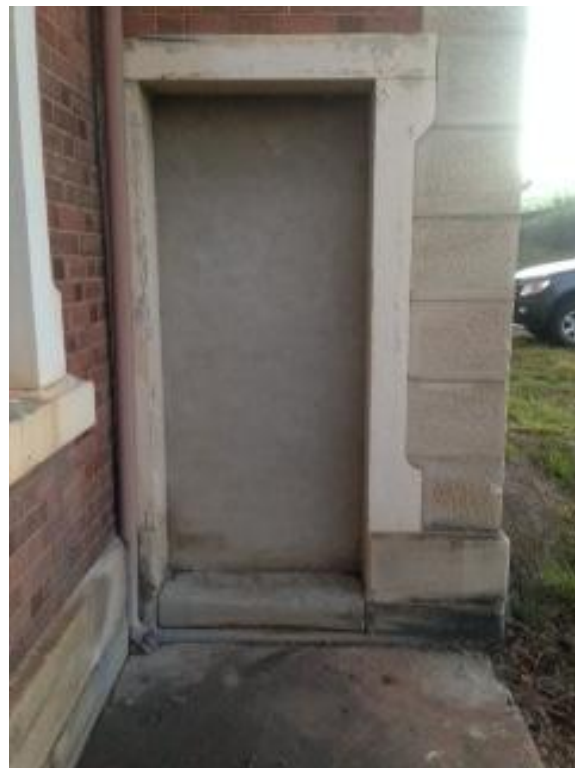
The Long term objective would be to remove all concrete and bitumen paving to ground level external to building and also remove all concrete slab floors within the building. It seems where the original timber floors have rotted out they have been replaced with concrete.

Concrete and bitumen seals the ground; this stops ground moisture from evaporating at ground level and forces excessive moisture into porous sandstone and brick walling. This excessive moisture held within walls then causes exfoliation and fretting of sandstone, damage to jointing and also causes wall plaster and render to become drummy, paint to peel, timber to rot etc.

I would advise a trial excavation to look for original ground level and original paving probably buried under concrete and bitumen.

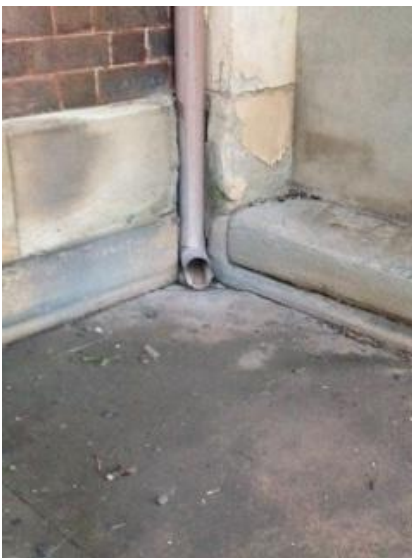
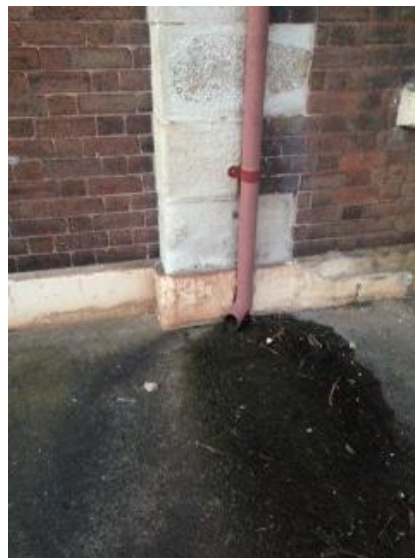
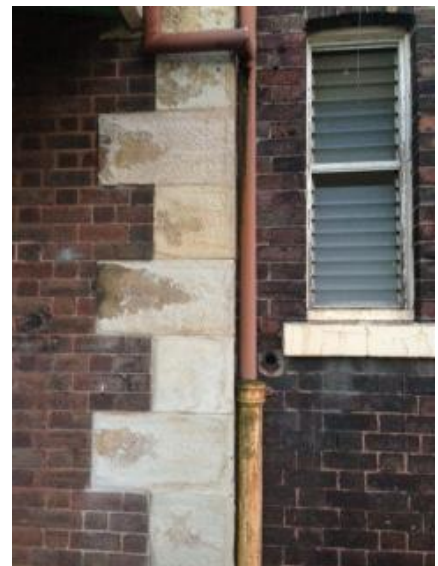
Leaking rooves, gutters, down pipes, storm water pipes, all contribute to excessive ground moisture.

- * inspect roof areas
- *refasten loose roofing iron and ridges
- *repair flashings to chimneys
- *clear gutters of blockages, repair as required
- *clear downpipes of obstructions, refasten where loose, replace where missing or leaking
- *clear storm water lines of blockages, establish outlet positions
- *provide additional storm water lines to downpipes currently out letting onto ground at base of walling

All downpipes to discharge into grated sumps connected to storm water. This will allow future access to downpipes and storm water lines for routine maintenance to clear blockages.

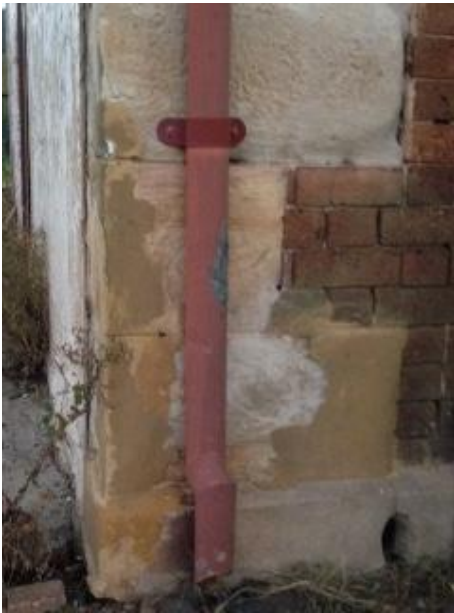
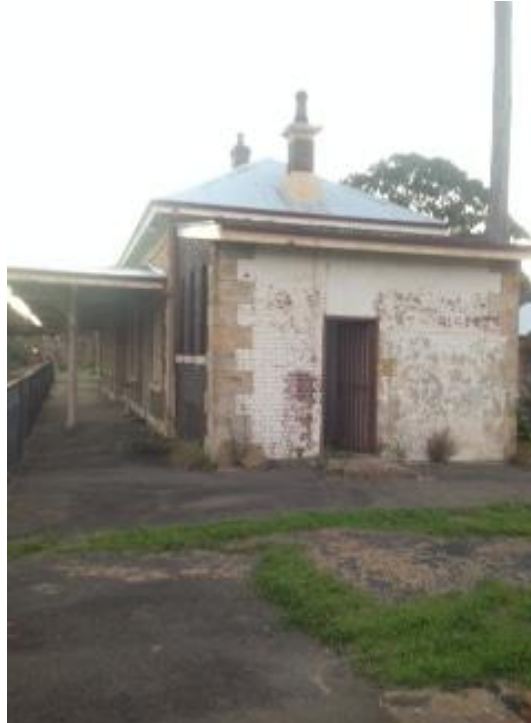
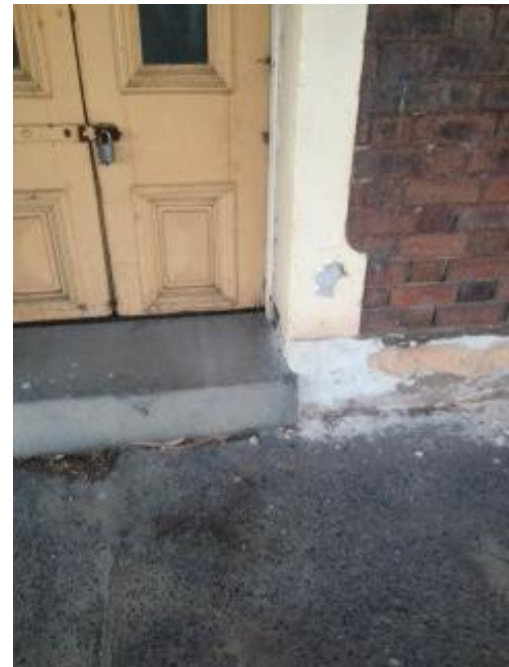
In many areas sandstone and brick walling has been coated in cement render and/or painted.

These coatings seal the surface and stop the porous masonry from 'breathing' forcing rising damp further up walling and increasing the area of walling suffering from fretting etc.

All of these coatings should be removed from external face of walling.

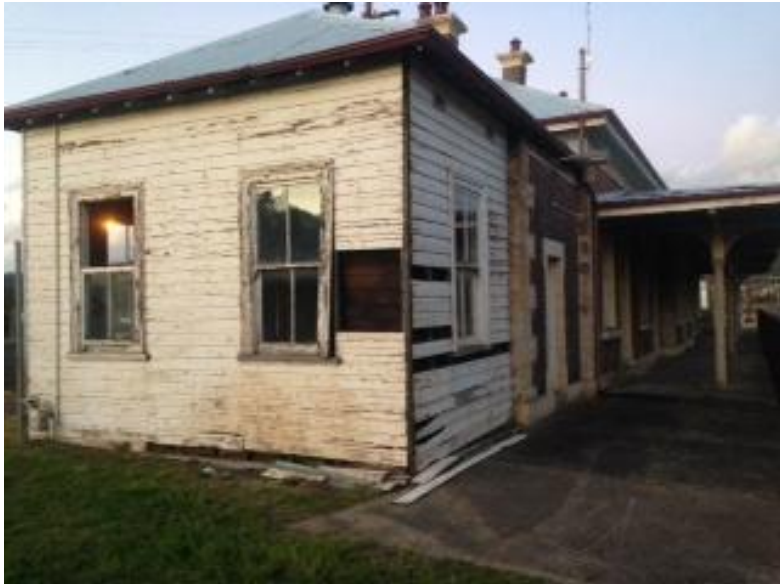
The original brick and stone wall at the western end of station building has been demolished and a weatherboard addition built.

To remove the weatherboard addition and build in brick and stone end wall to match original design would reinstate the symmetry and return the building to its original design.

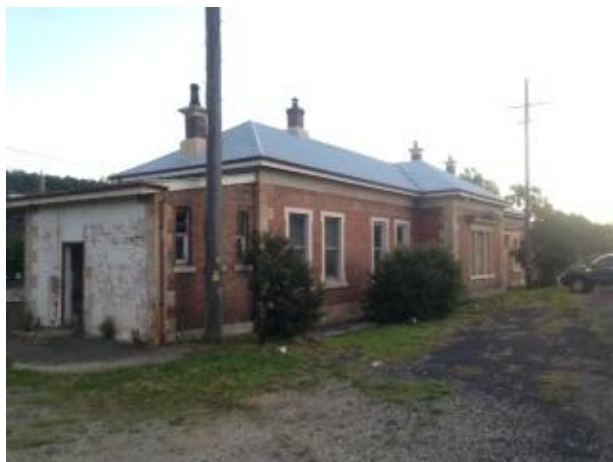
One of the chimneys has lost its sandstone chimney capping. To supply, shape and install capping to match original, I would [REDACTED].

Missing chimney capping (second from left)
